# Use of Earth Observation for Disaster Response: Case Study From Sri Lanka

Srimal Samansiri Assistant Director Disaster Management Centre Sri Lanka

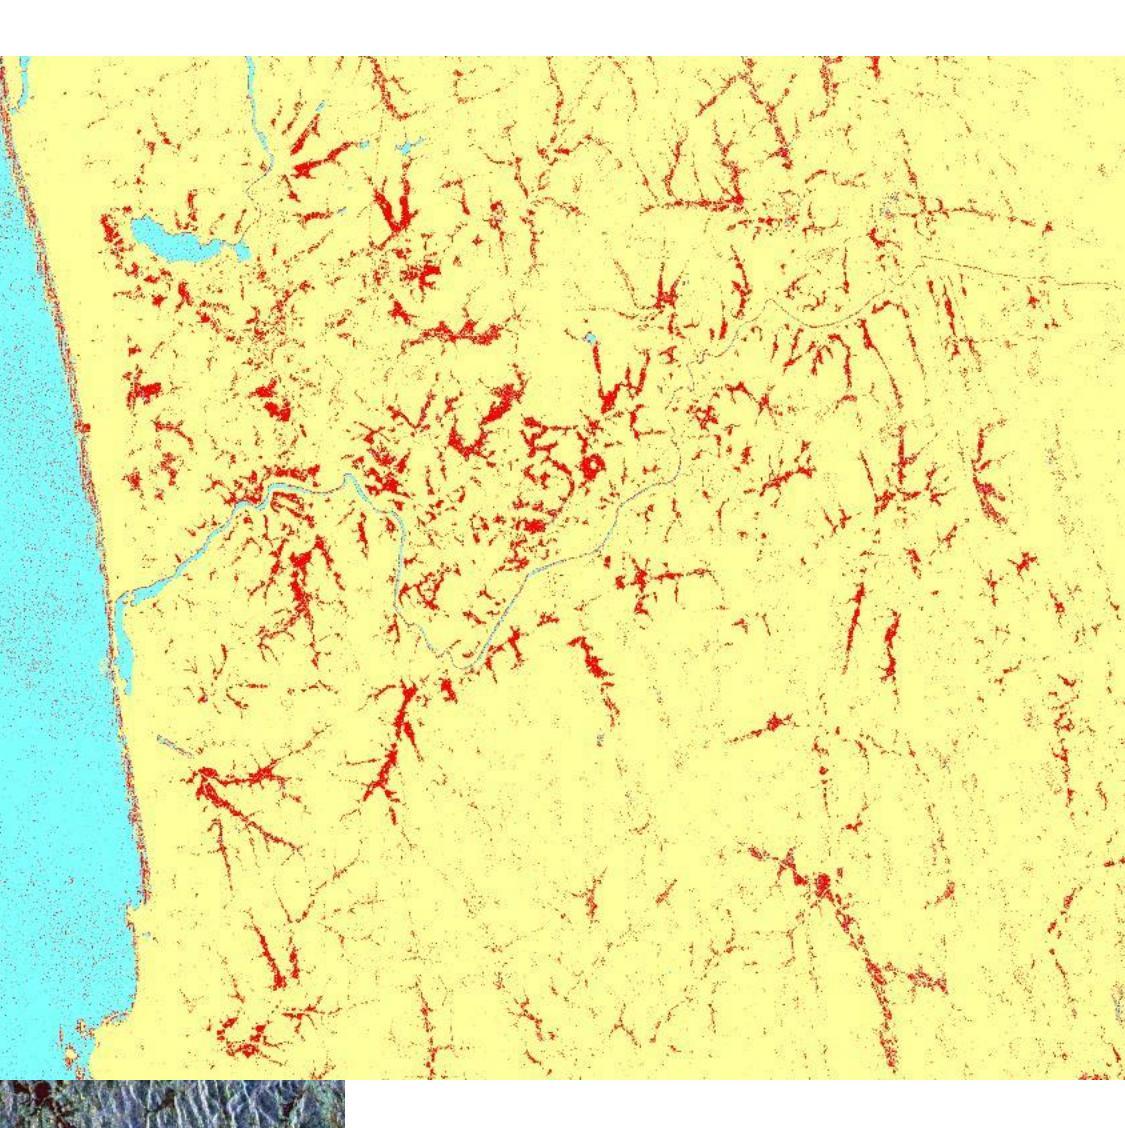
Kalutara District - Floods 2008/06/03 ALOS Data

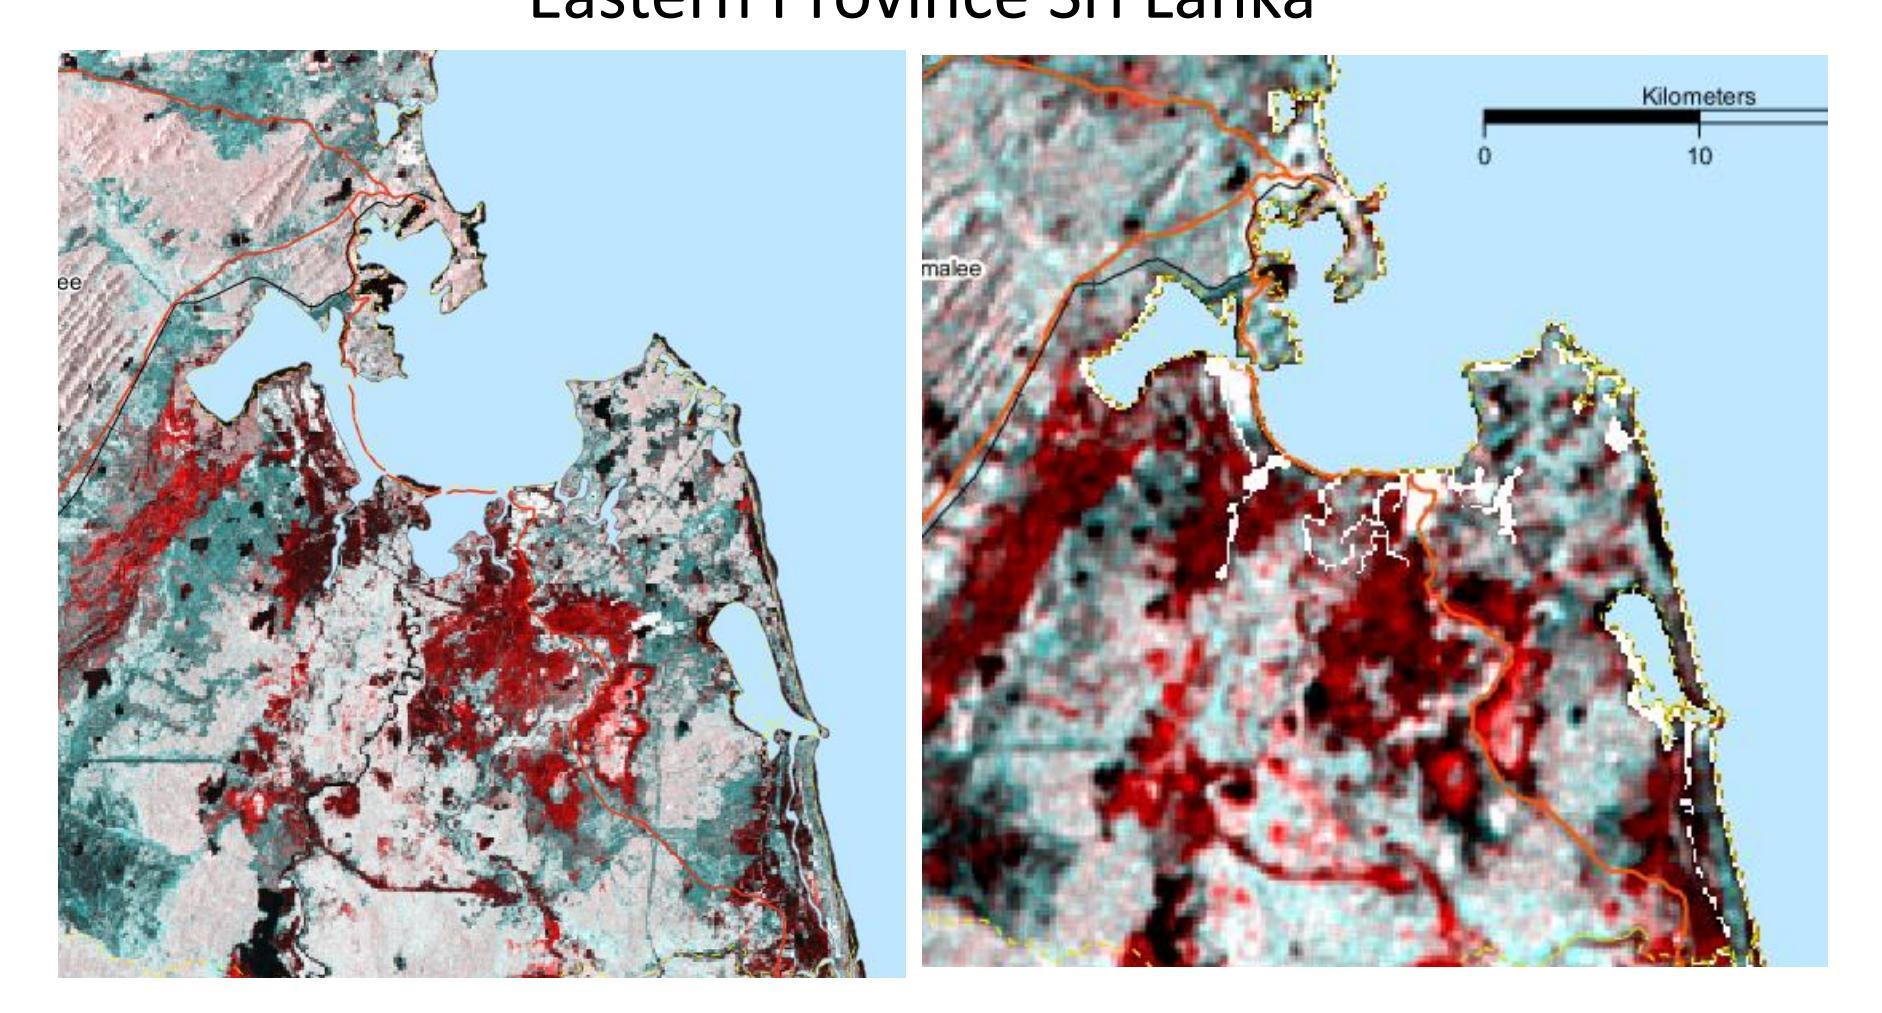
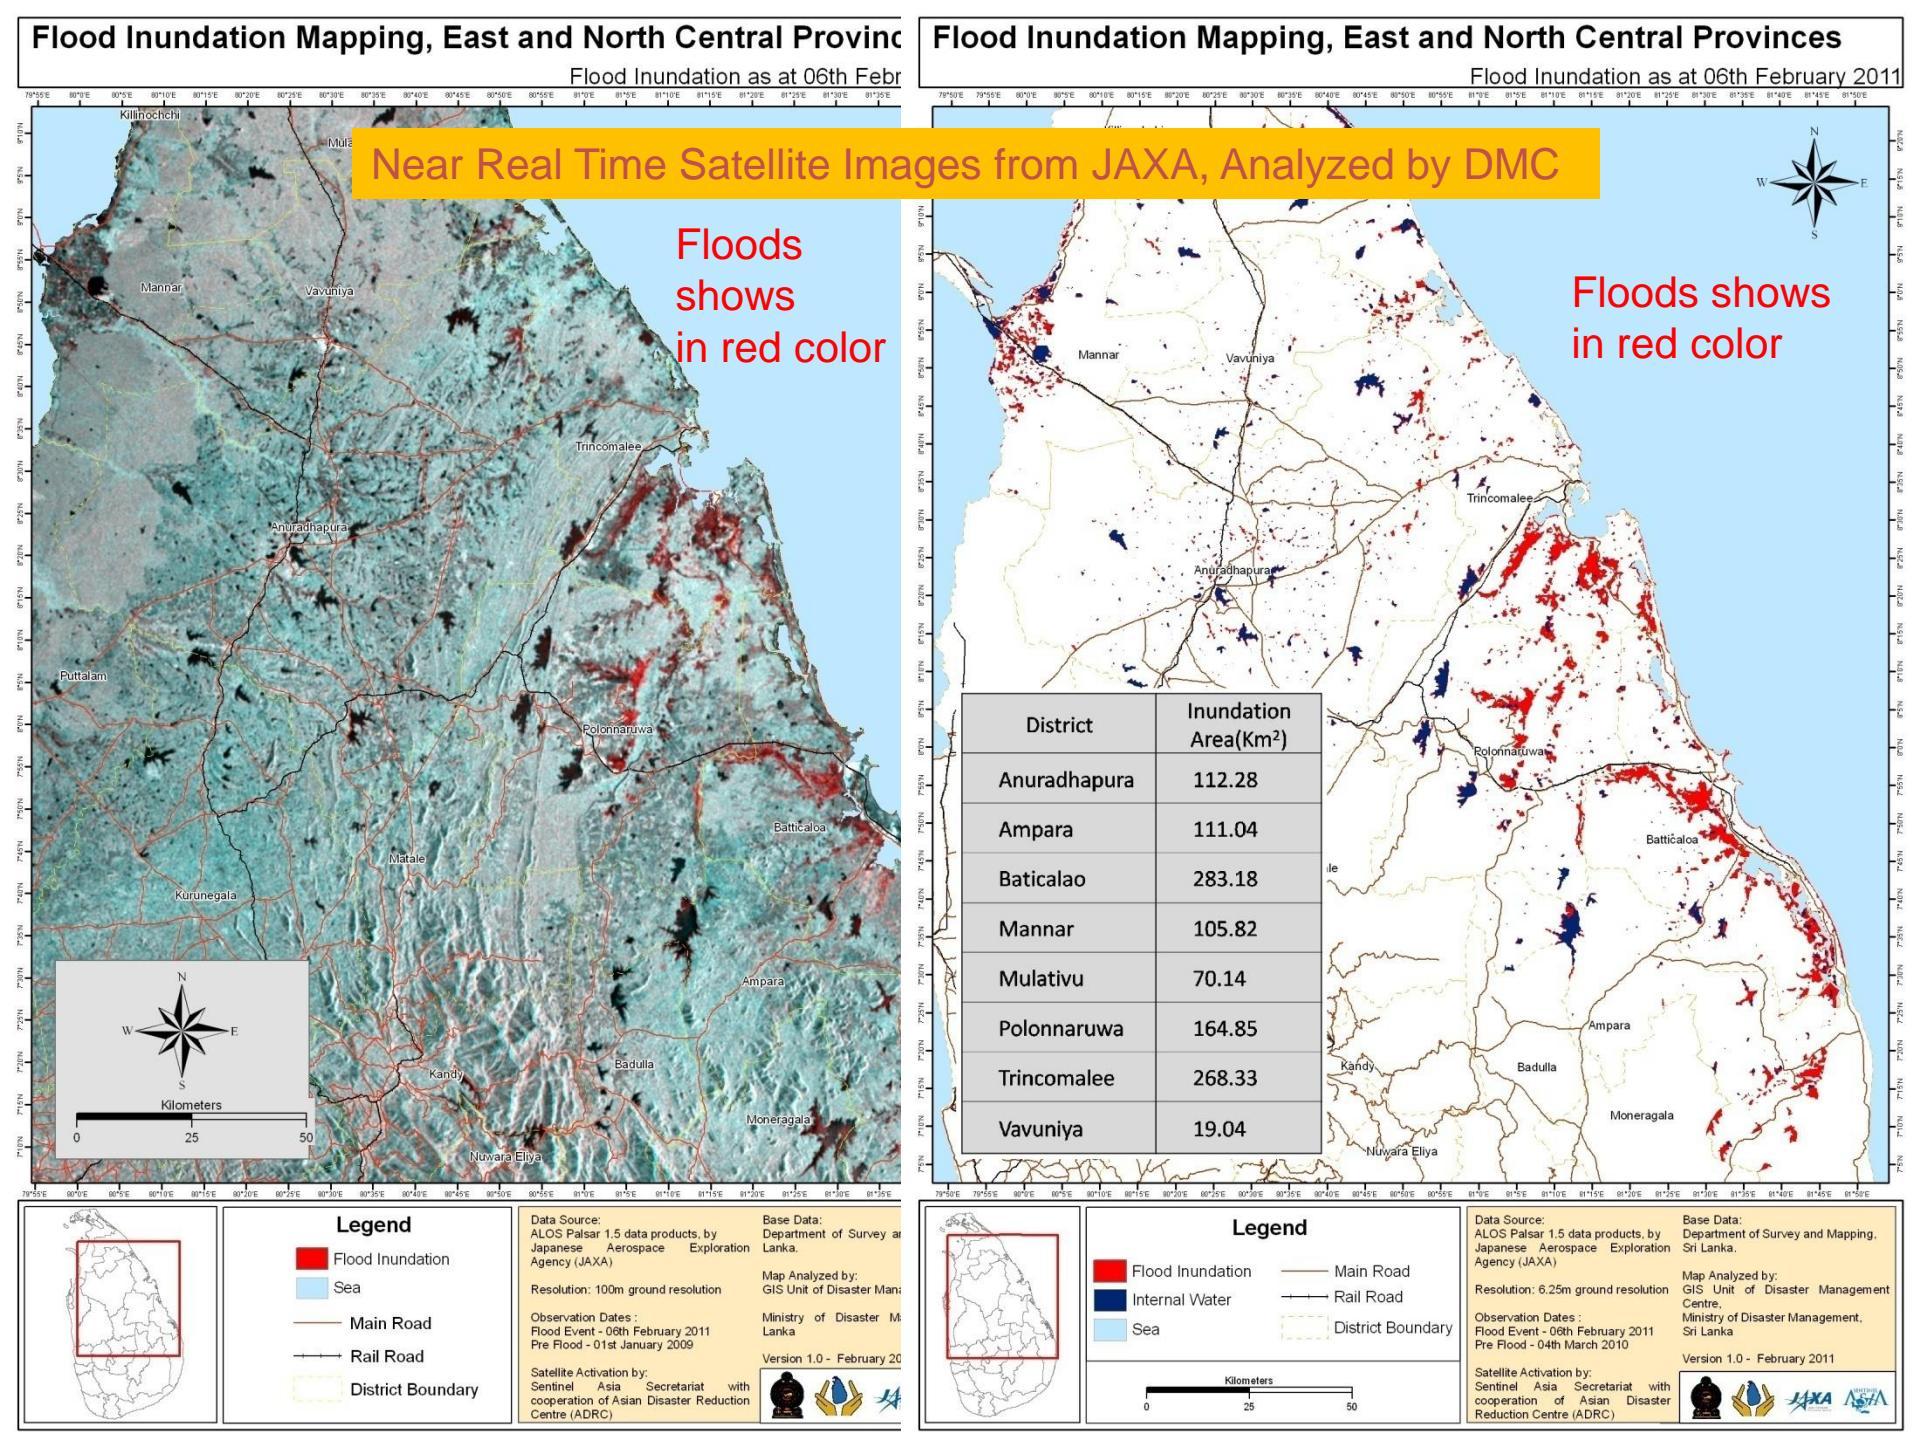
10.30 am 06th Feb. 2011 PALSAR 6m

11.45 pm 06th Feb. 2011 PALSAR 100m

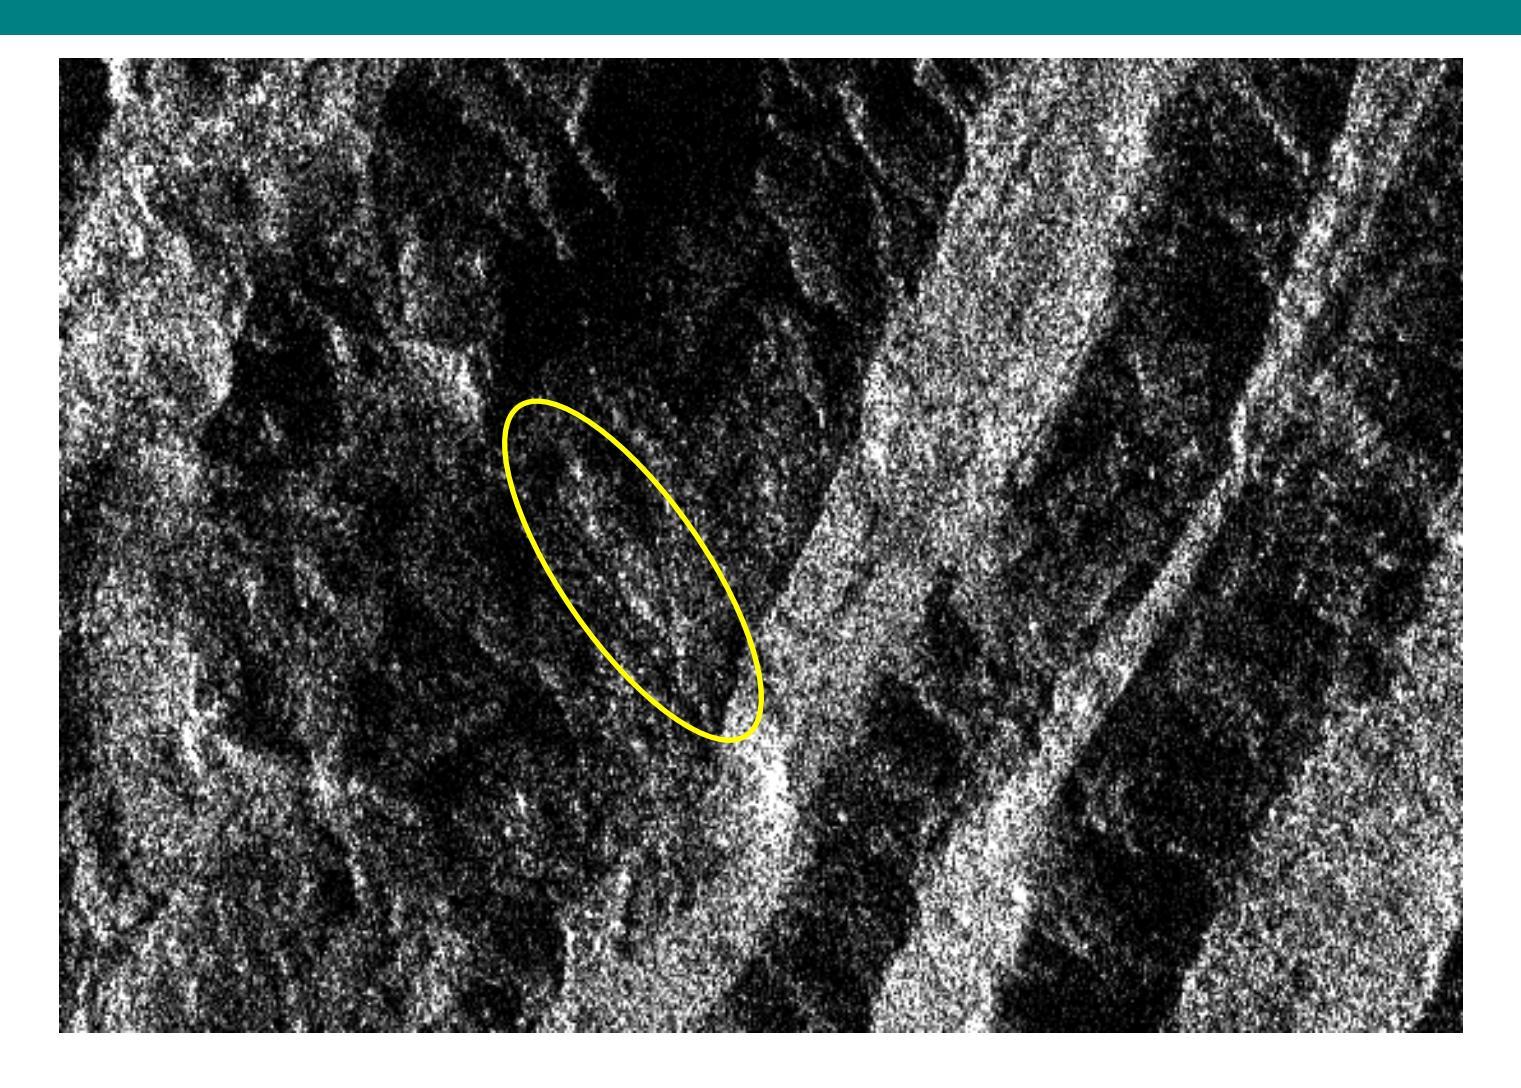
### Meeriyabedda Landslide – Sentinel Asia (ALOS2)

Acquisition 31 Oct 2014

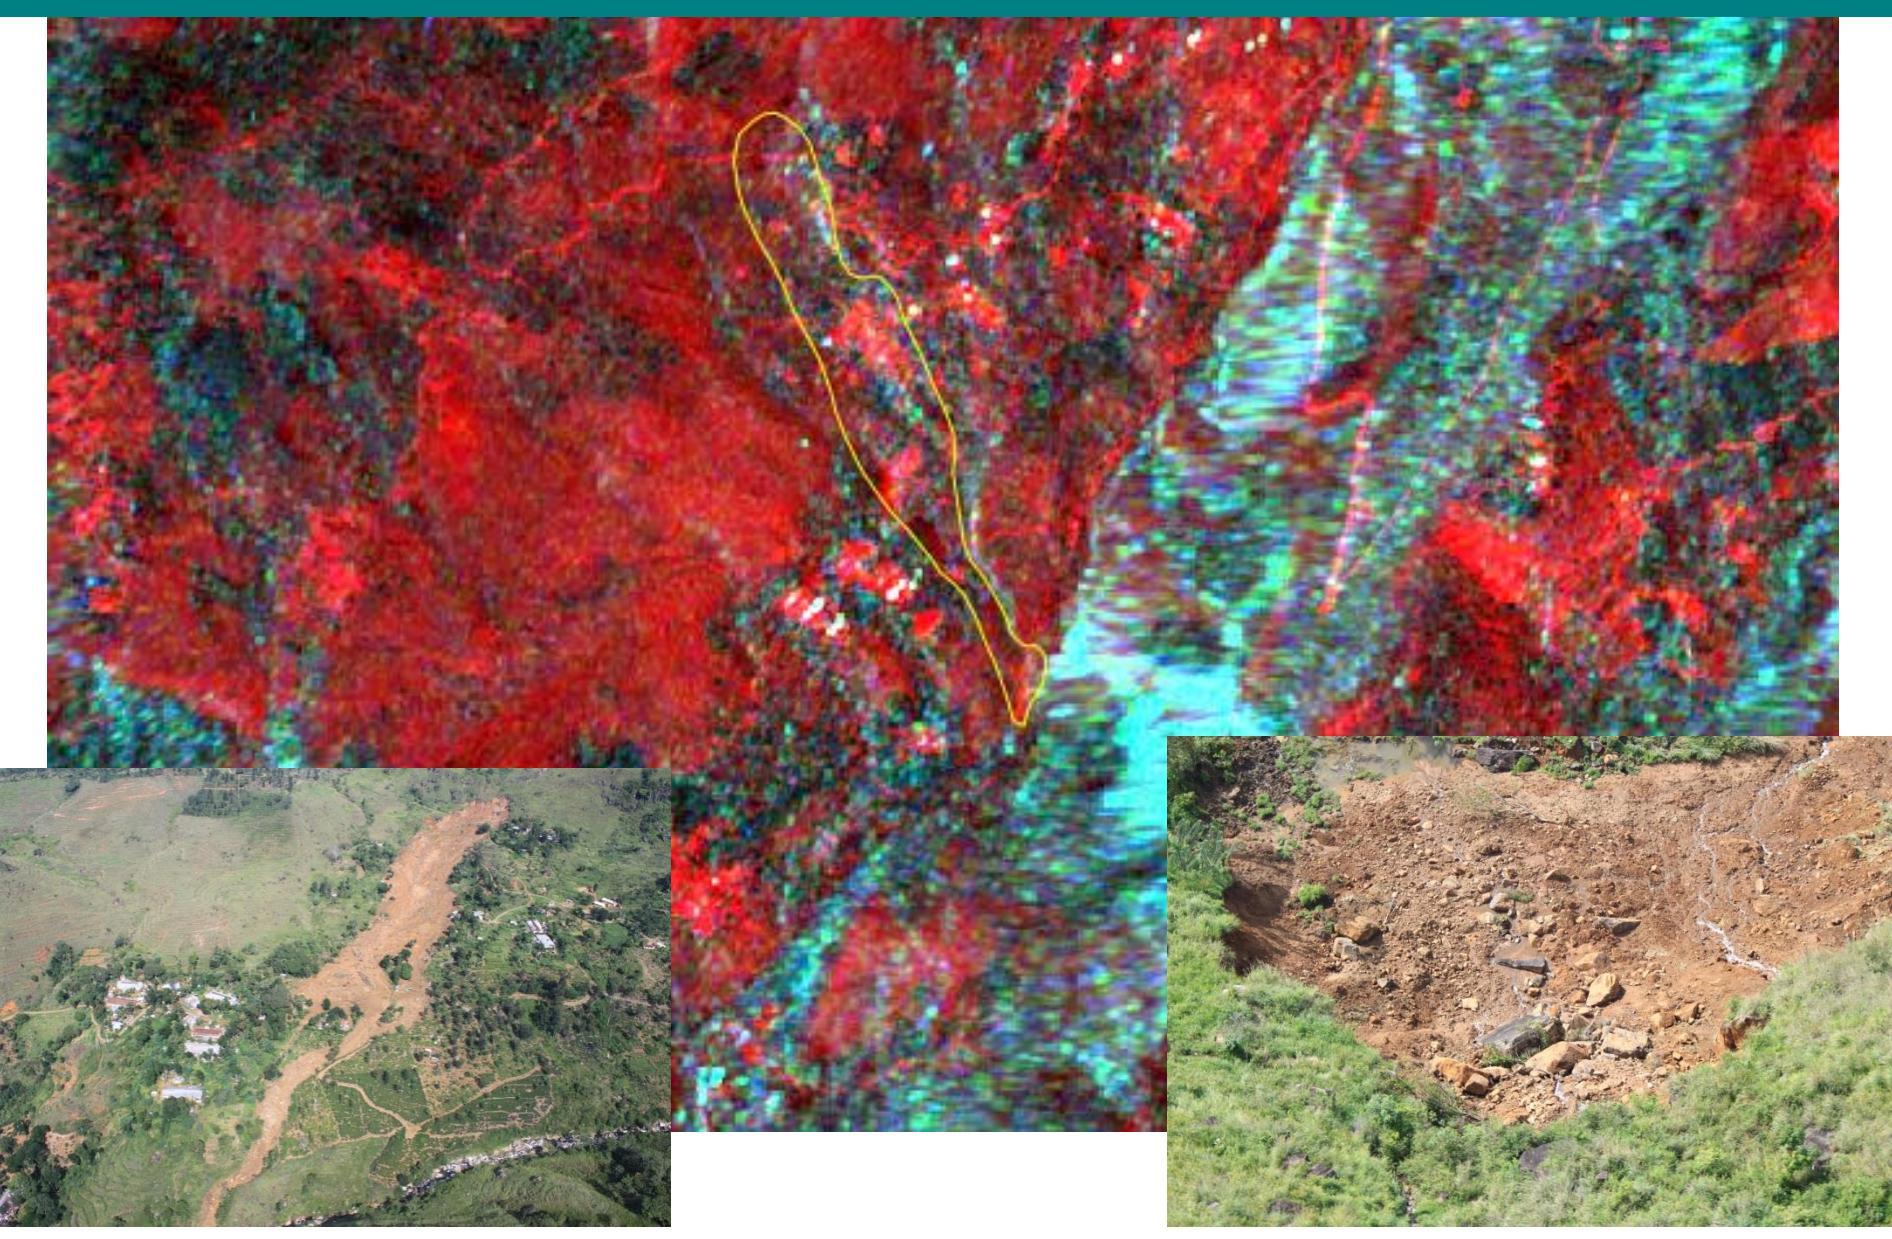
### Meeriyabedda Landslide – Intnl Charter (Terra SAR X)

Acquisition 04 Nov 2014

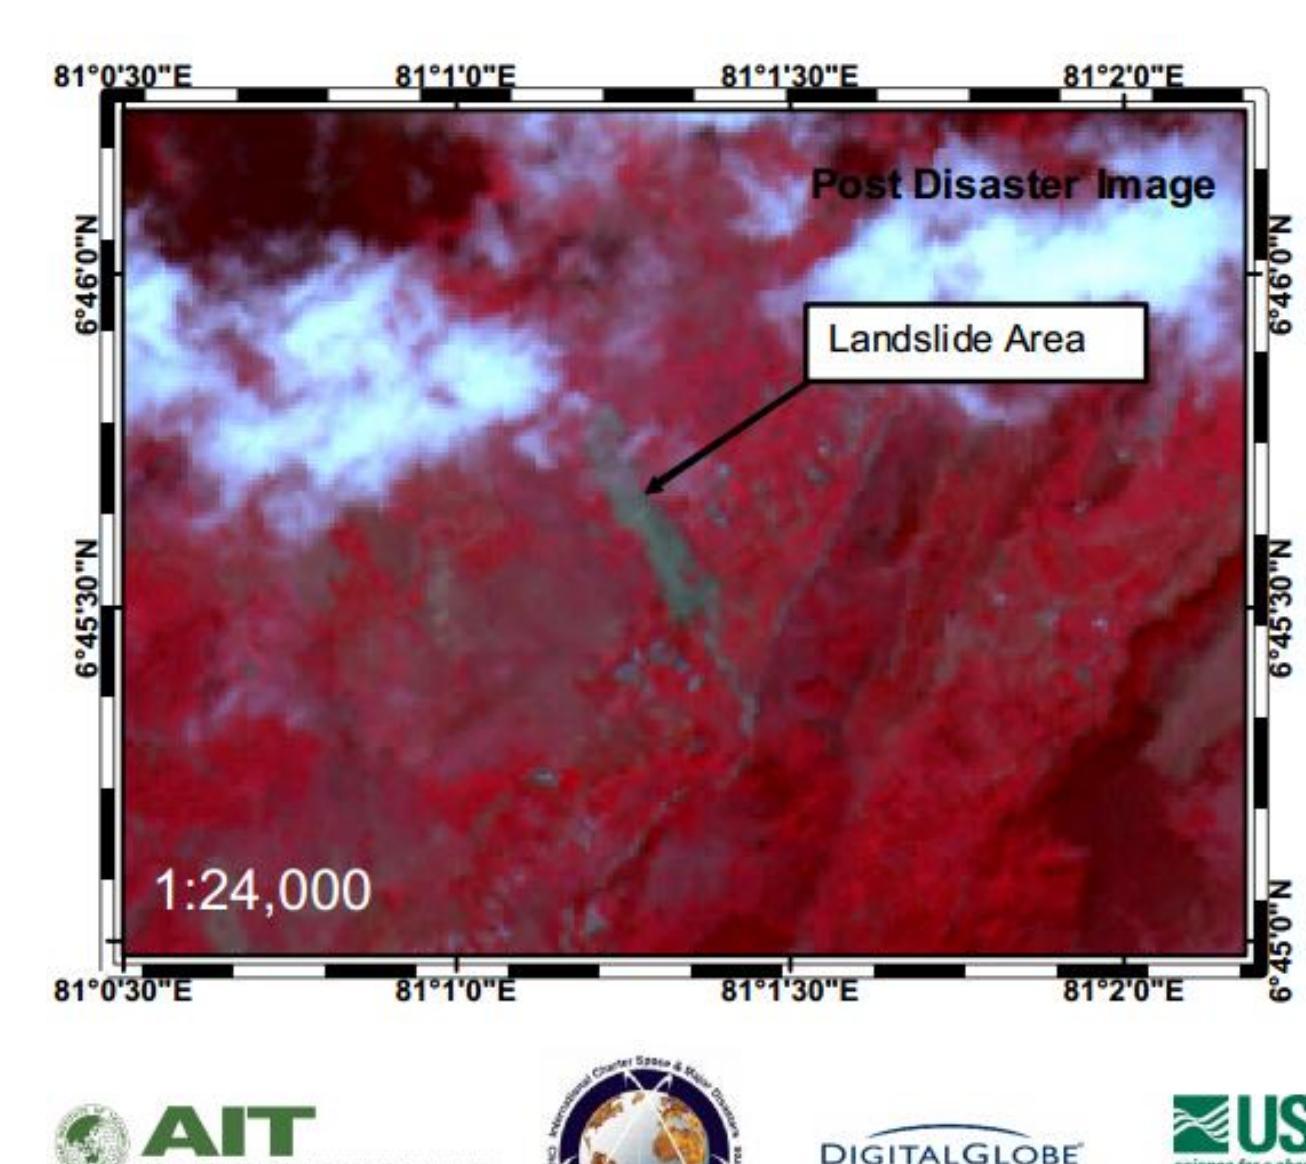
### Meeriyabedda Landslide – International Charter (ASTER)

disaster images were acquired by ASTER satellite. Please note that the accuracy of the product is not guaranteed.

Pre Image: World View 2 Resolution: 2m Acquisition Date: 08 - April-2012 Copyright: (C) COPYRIGHT 2012 DigitalGlobe Post Image: ASTER Resolution: 15m Acquisition Date: 06-Nov-2014 Coordinate System: Geographic Datum: WGS 1984 Unit: Degree

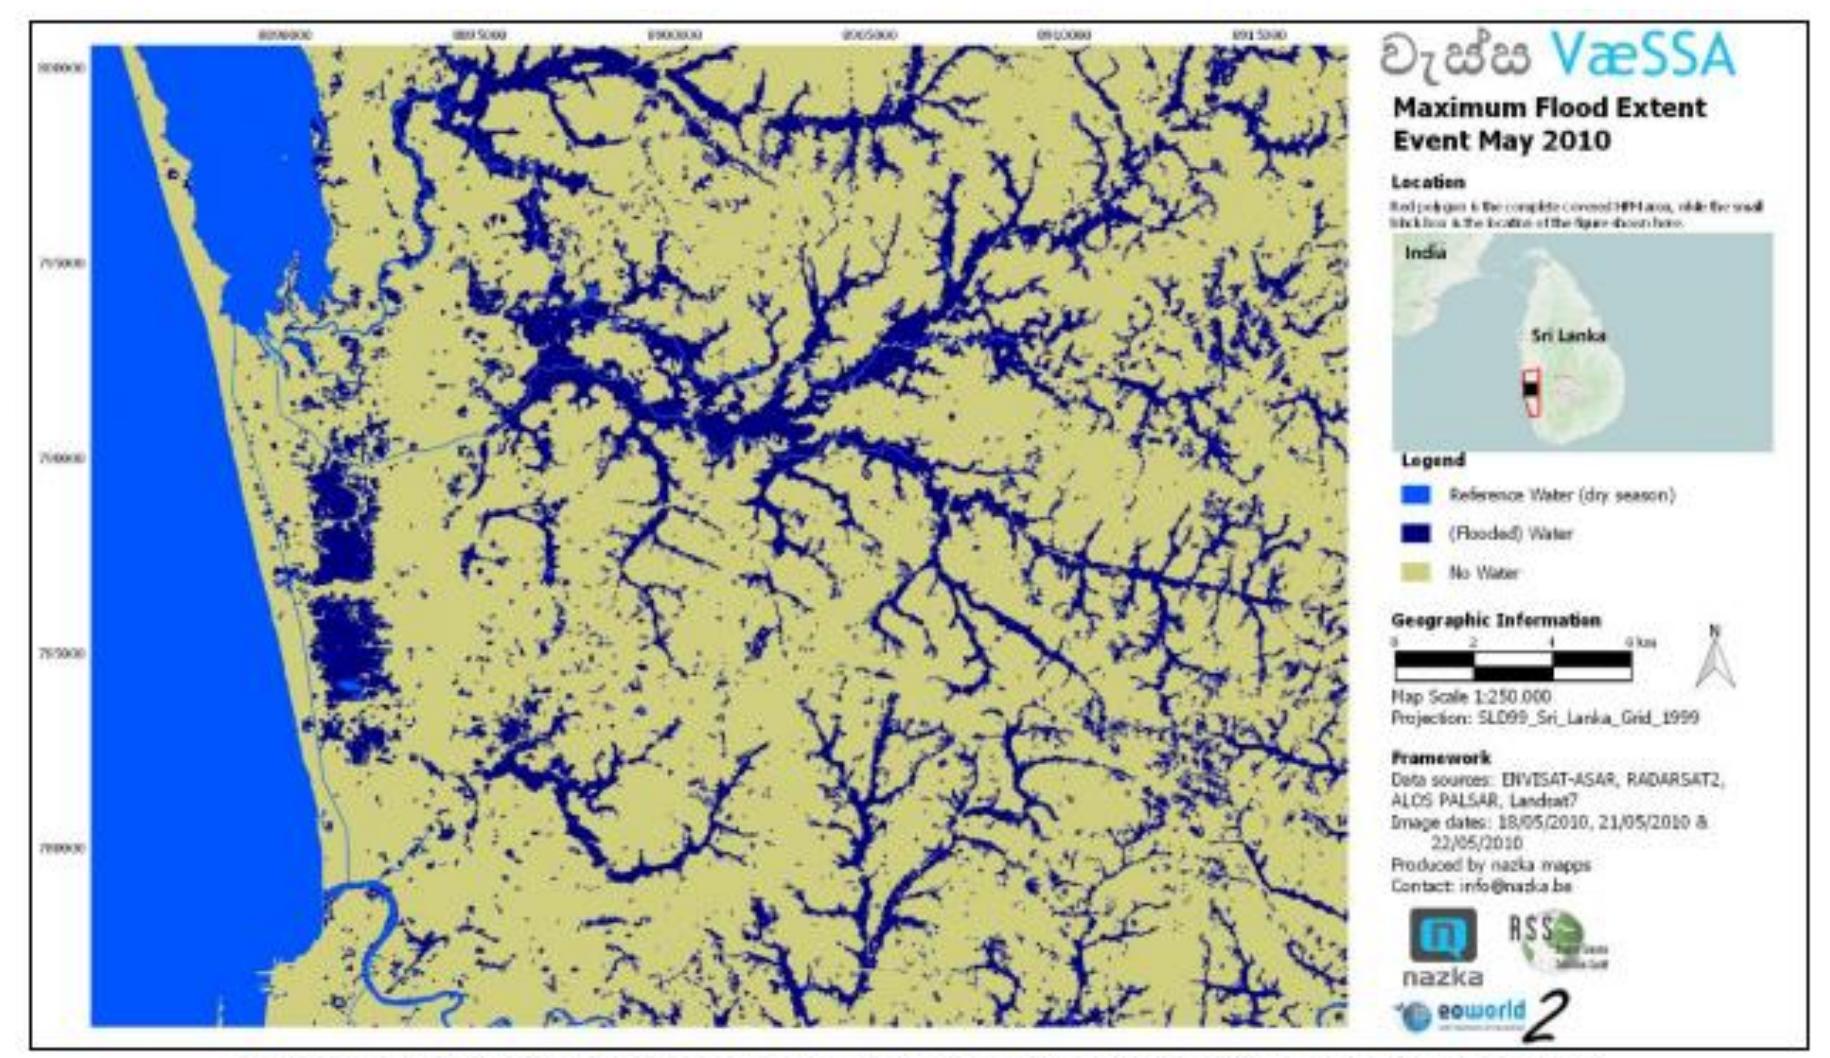
Figure 3: Part of the Maximum Flood Extent map in Western Sri Lanka in May 2010

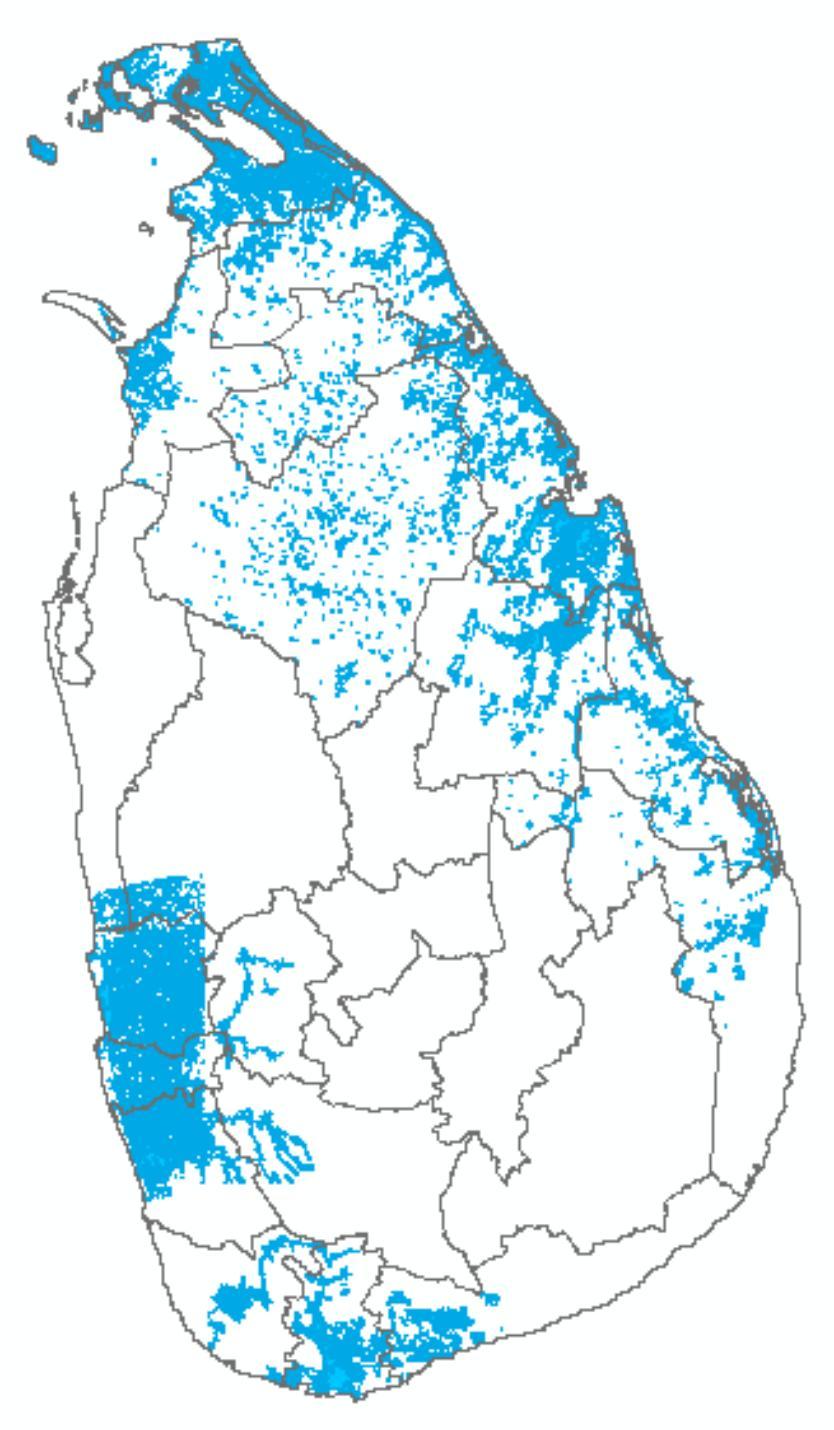
Flood Map of Sri Lanka

Compiled based satellite and field observation

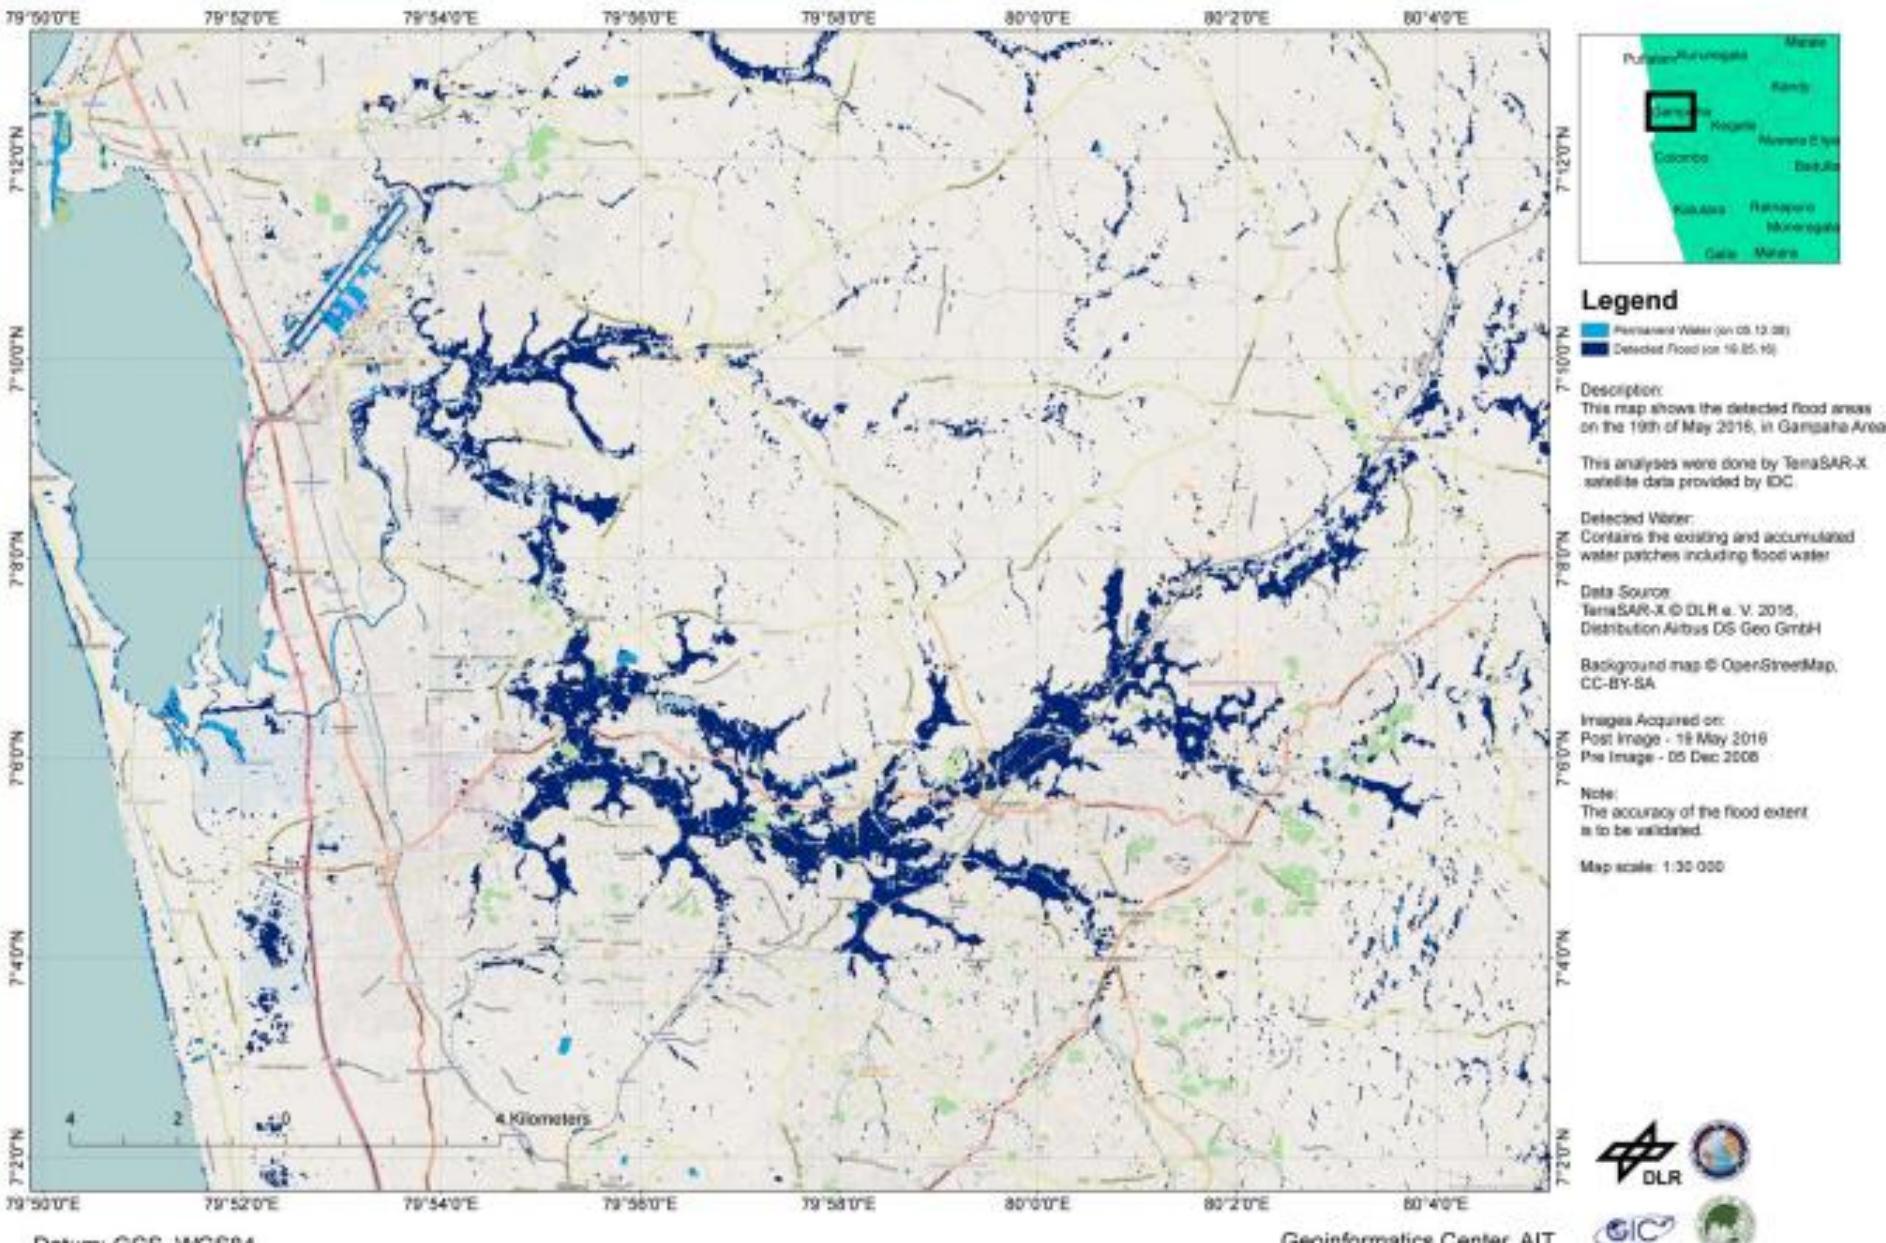
#### FLOOD IN GAMPAHA, SRI LANKA - Detected by TerraSAR-X on 19.05.2016

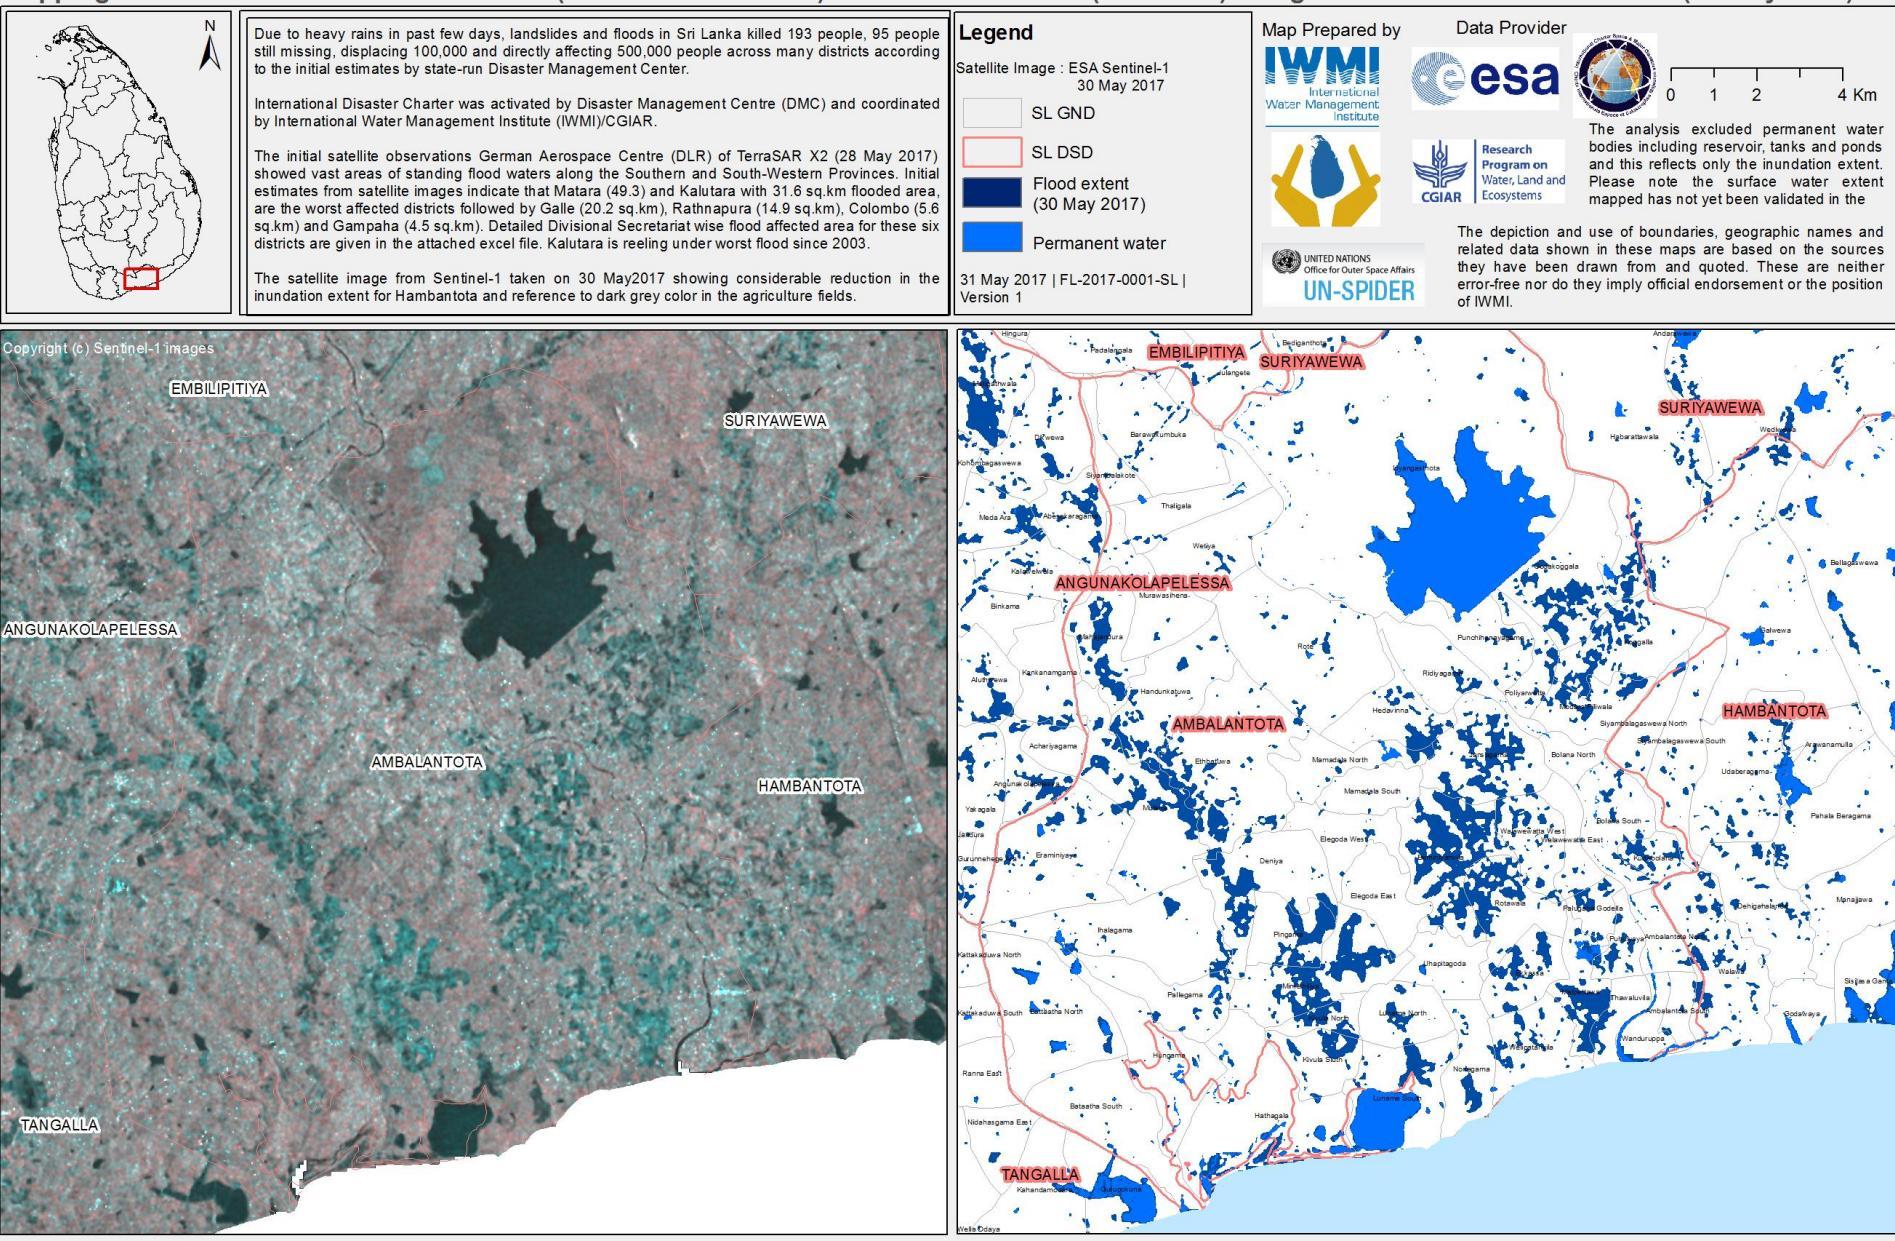
#### Flood May 2017 - Walawe

Mapping Inundation extent for Ambalantota (Hambantota District) in Suthern Province (Sri Lanka) using ESA Sentinel-1 Satellite Data (30 May 2017)

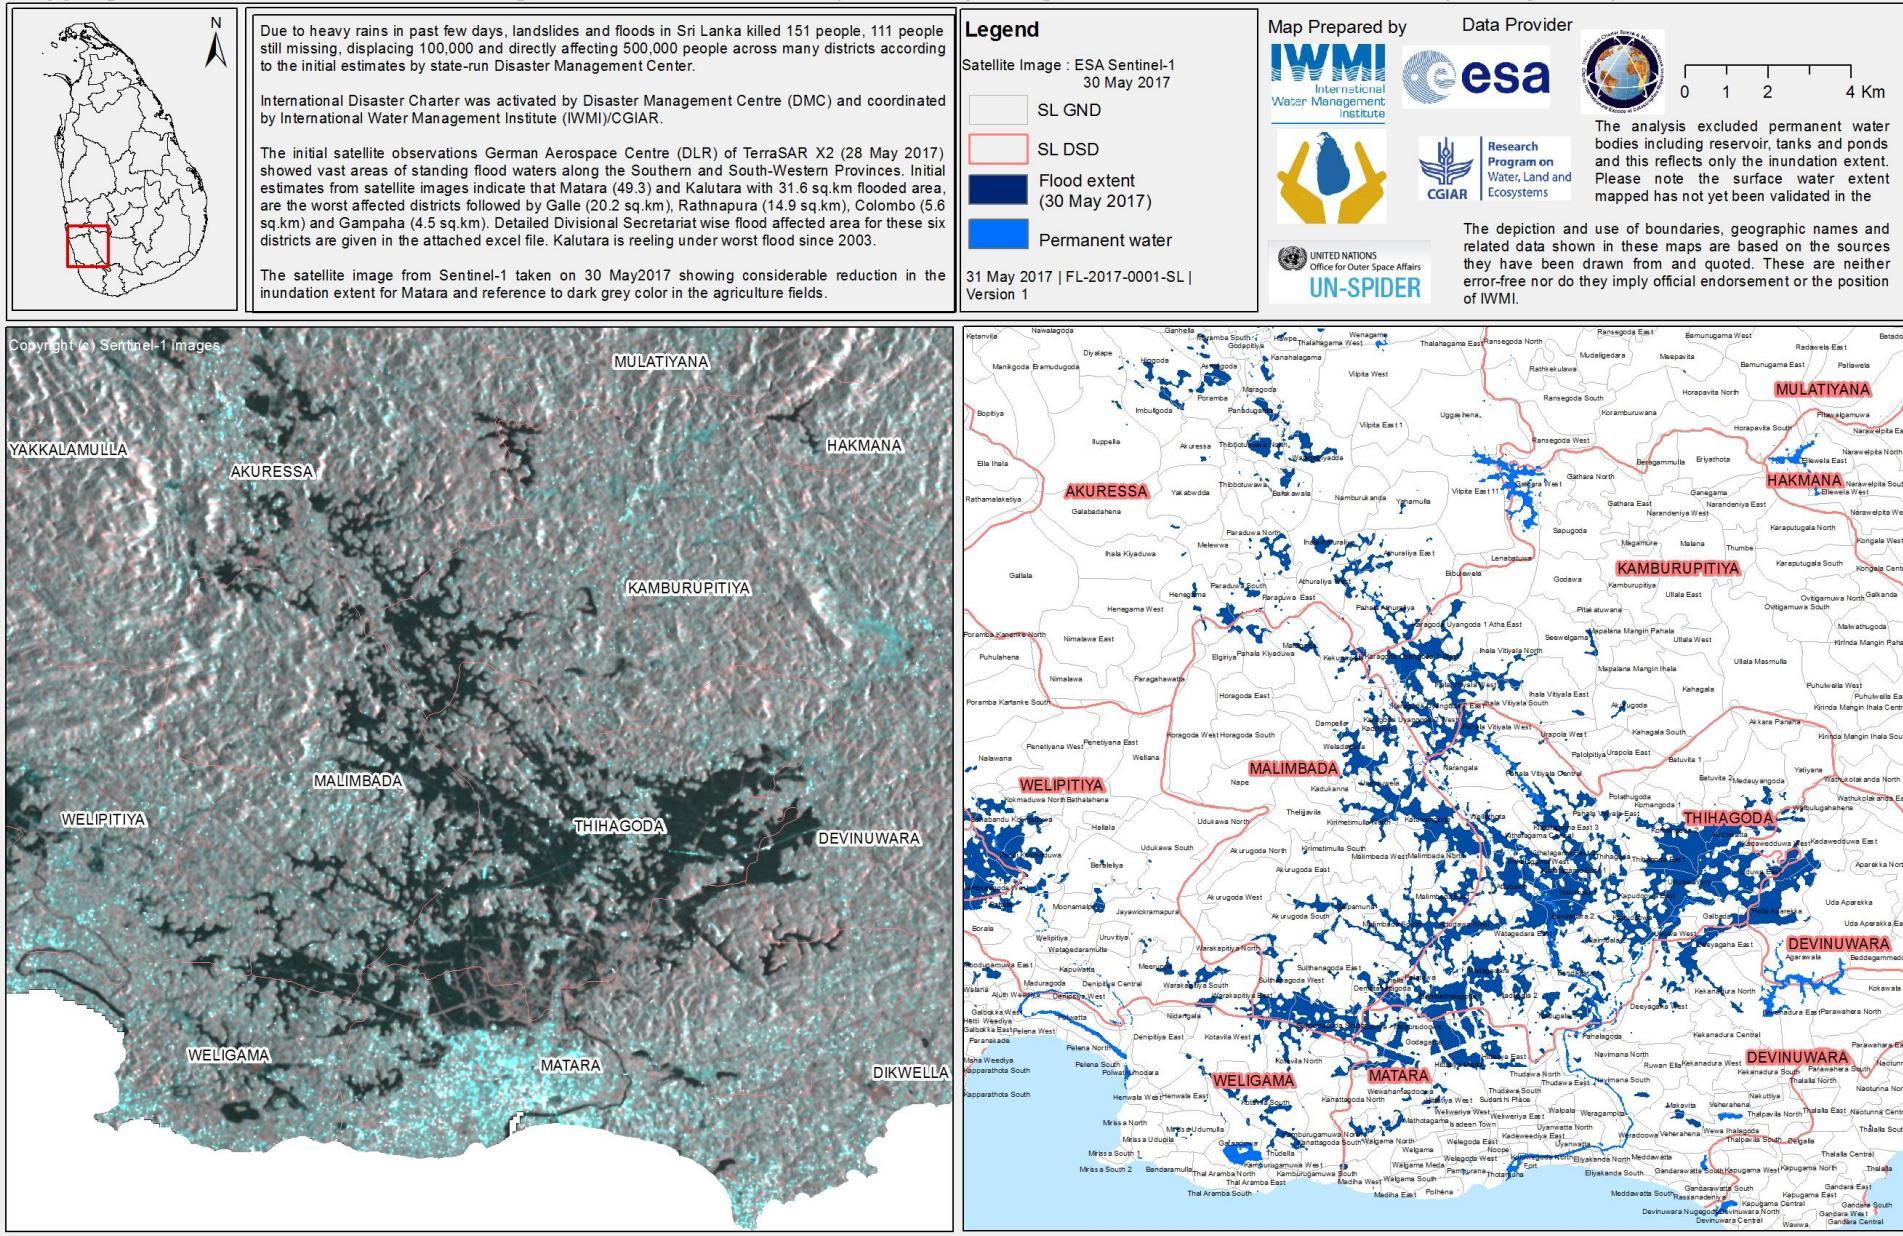
### Flood May 2017 – Nilwala River

Mapping Inundation extent for Gin Ganga in Southern Province (Sri Lanka) using ESA Sentinel-1 Satellite Data (30 May 2017)
