# Use of Earth Observation for Disaster Response: Case Study From Sri Lanka

Srimal Samansiri Assistant Director Disaster Management Centre Sri Lanka

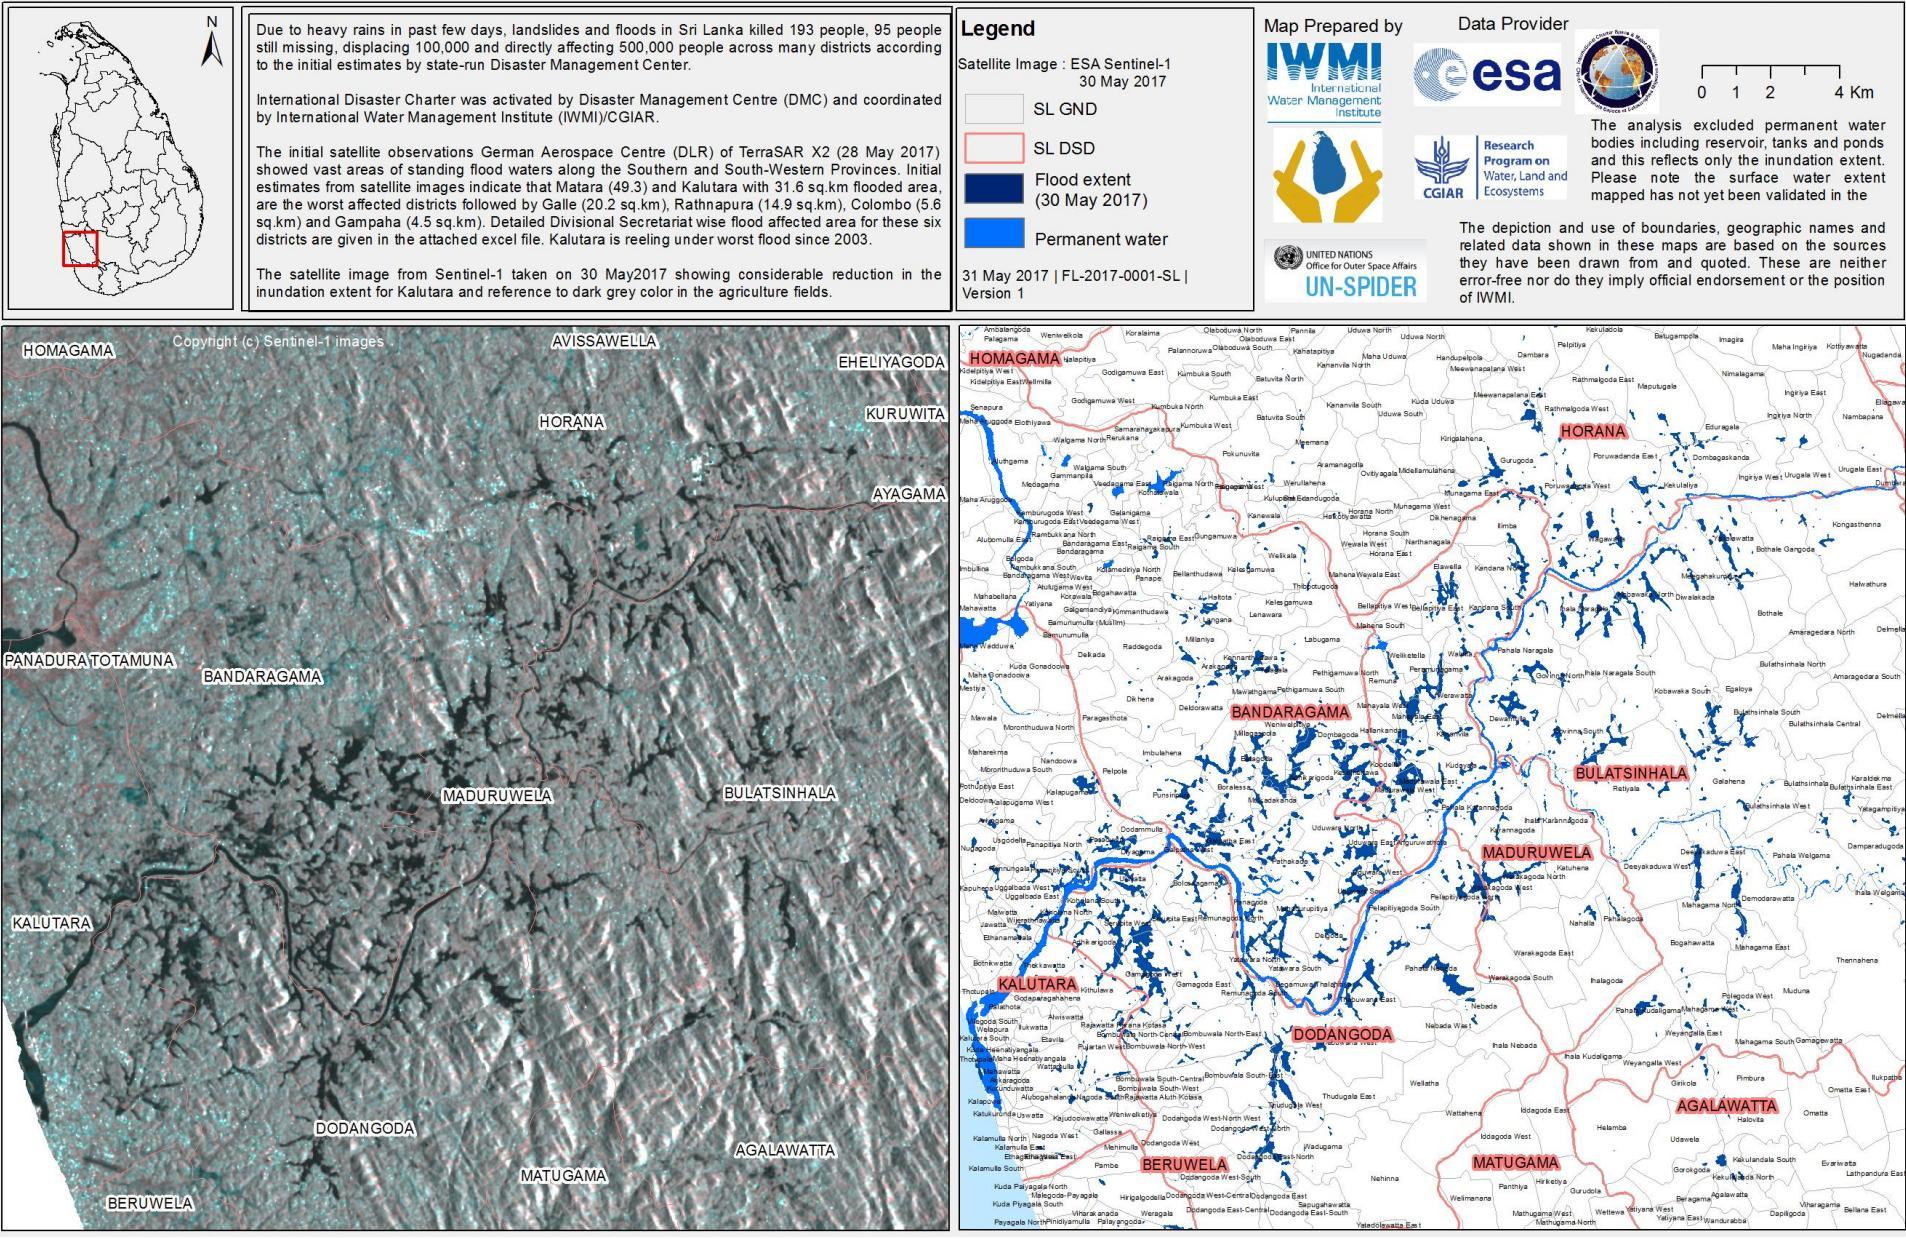
### Flood May 2017 - Kalu

Mapping Inundation extent for Kalutara District in Western Province (Sri Lanka) using ESA Sentinel-1 Satellite Data (30 May 2017)

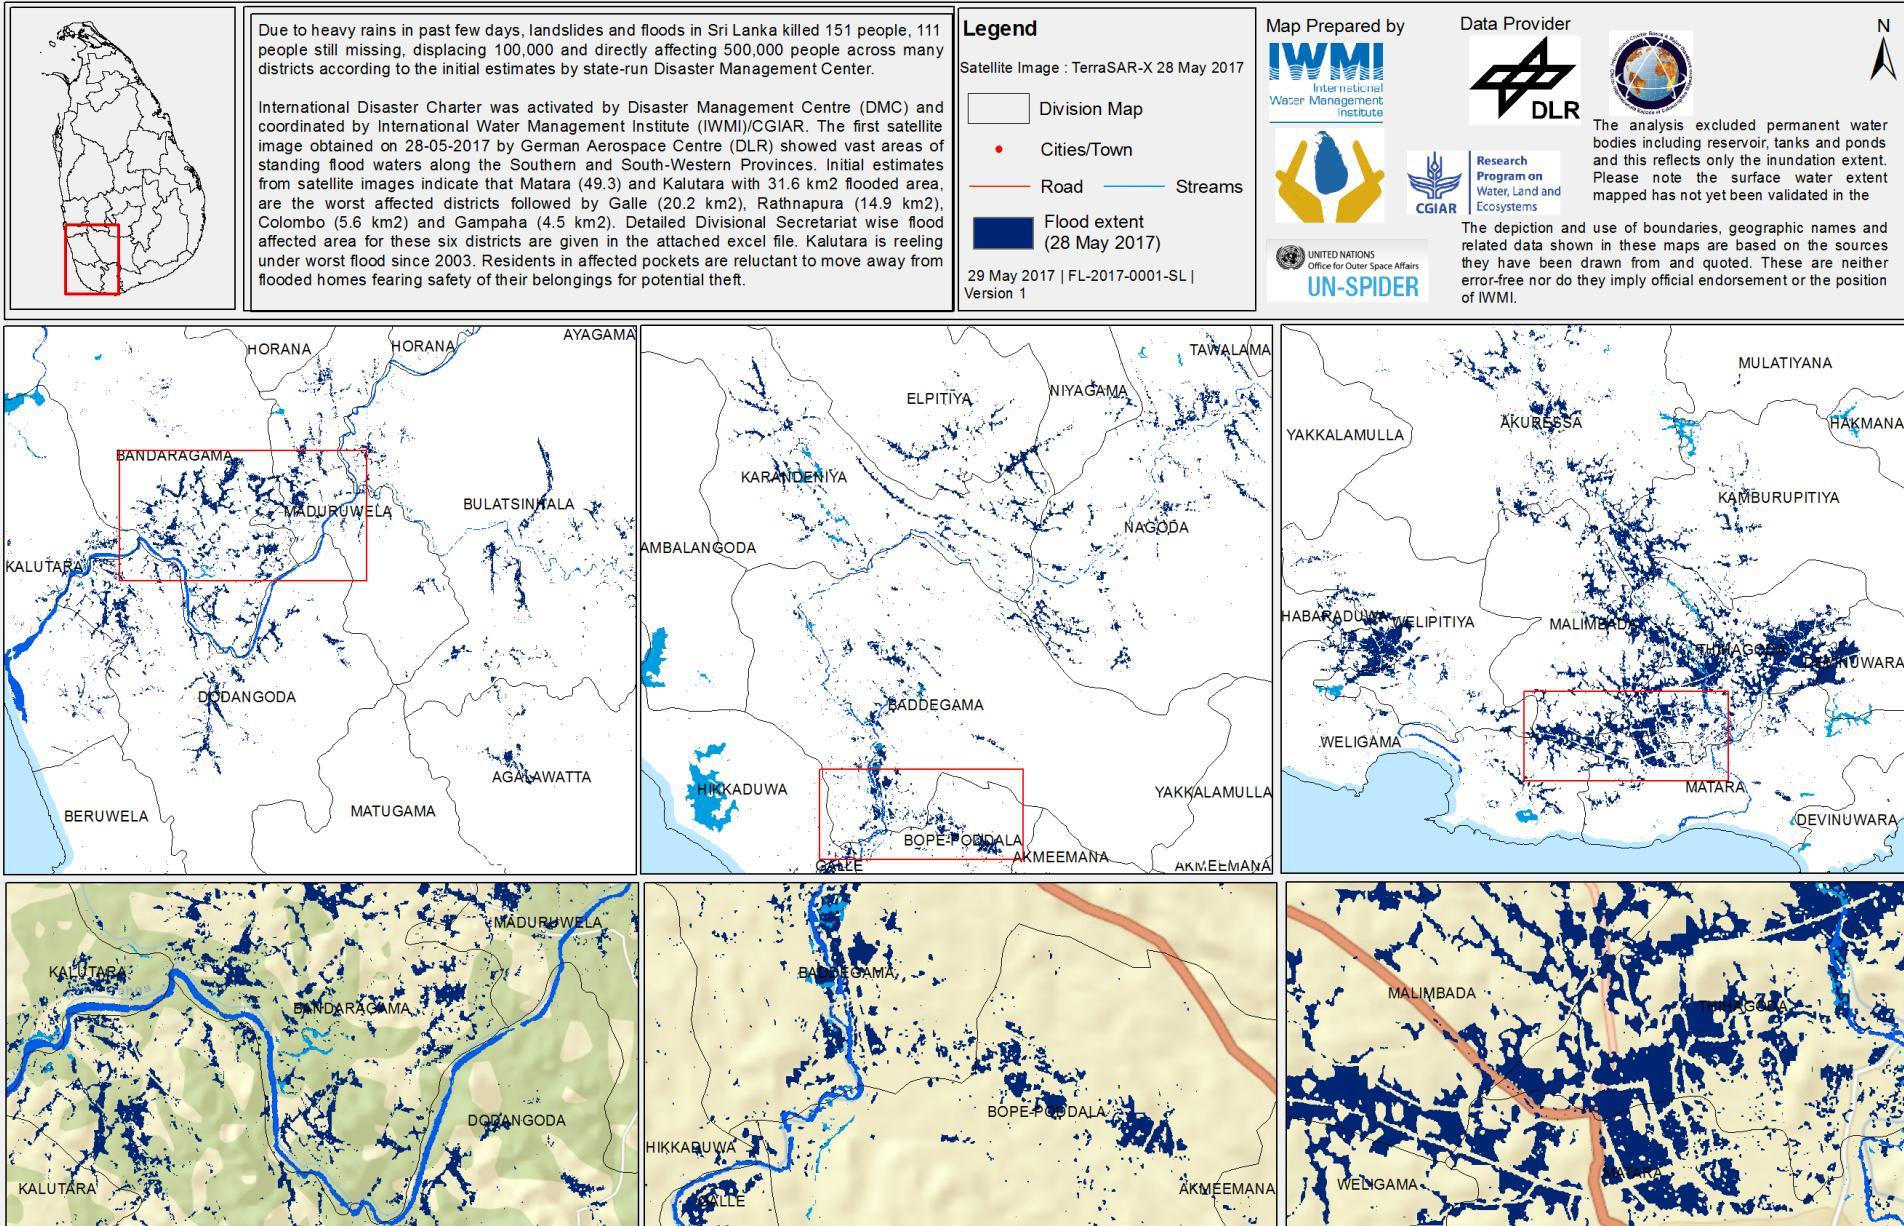
### Flood May 2017 - Kalu

Mapping Inundation extent for Southern and parts of Western and Sabaragamuwa Provinces in Sri Lanka using TerraSAR-X Satellite Data

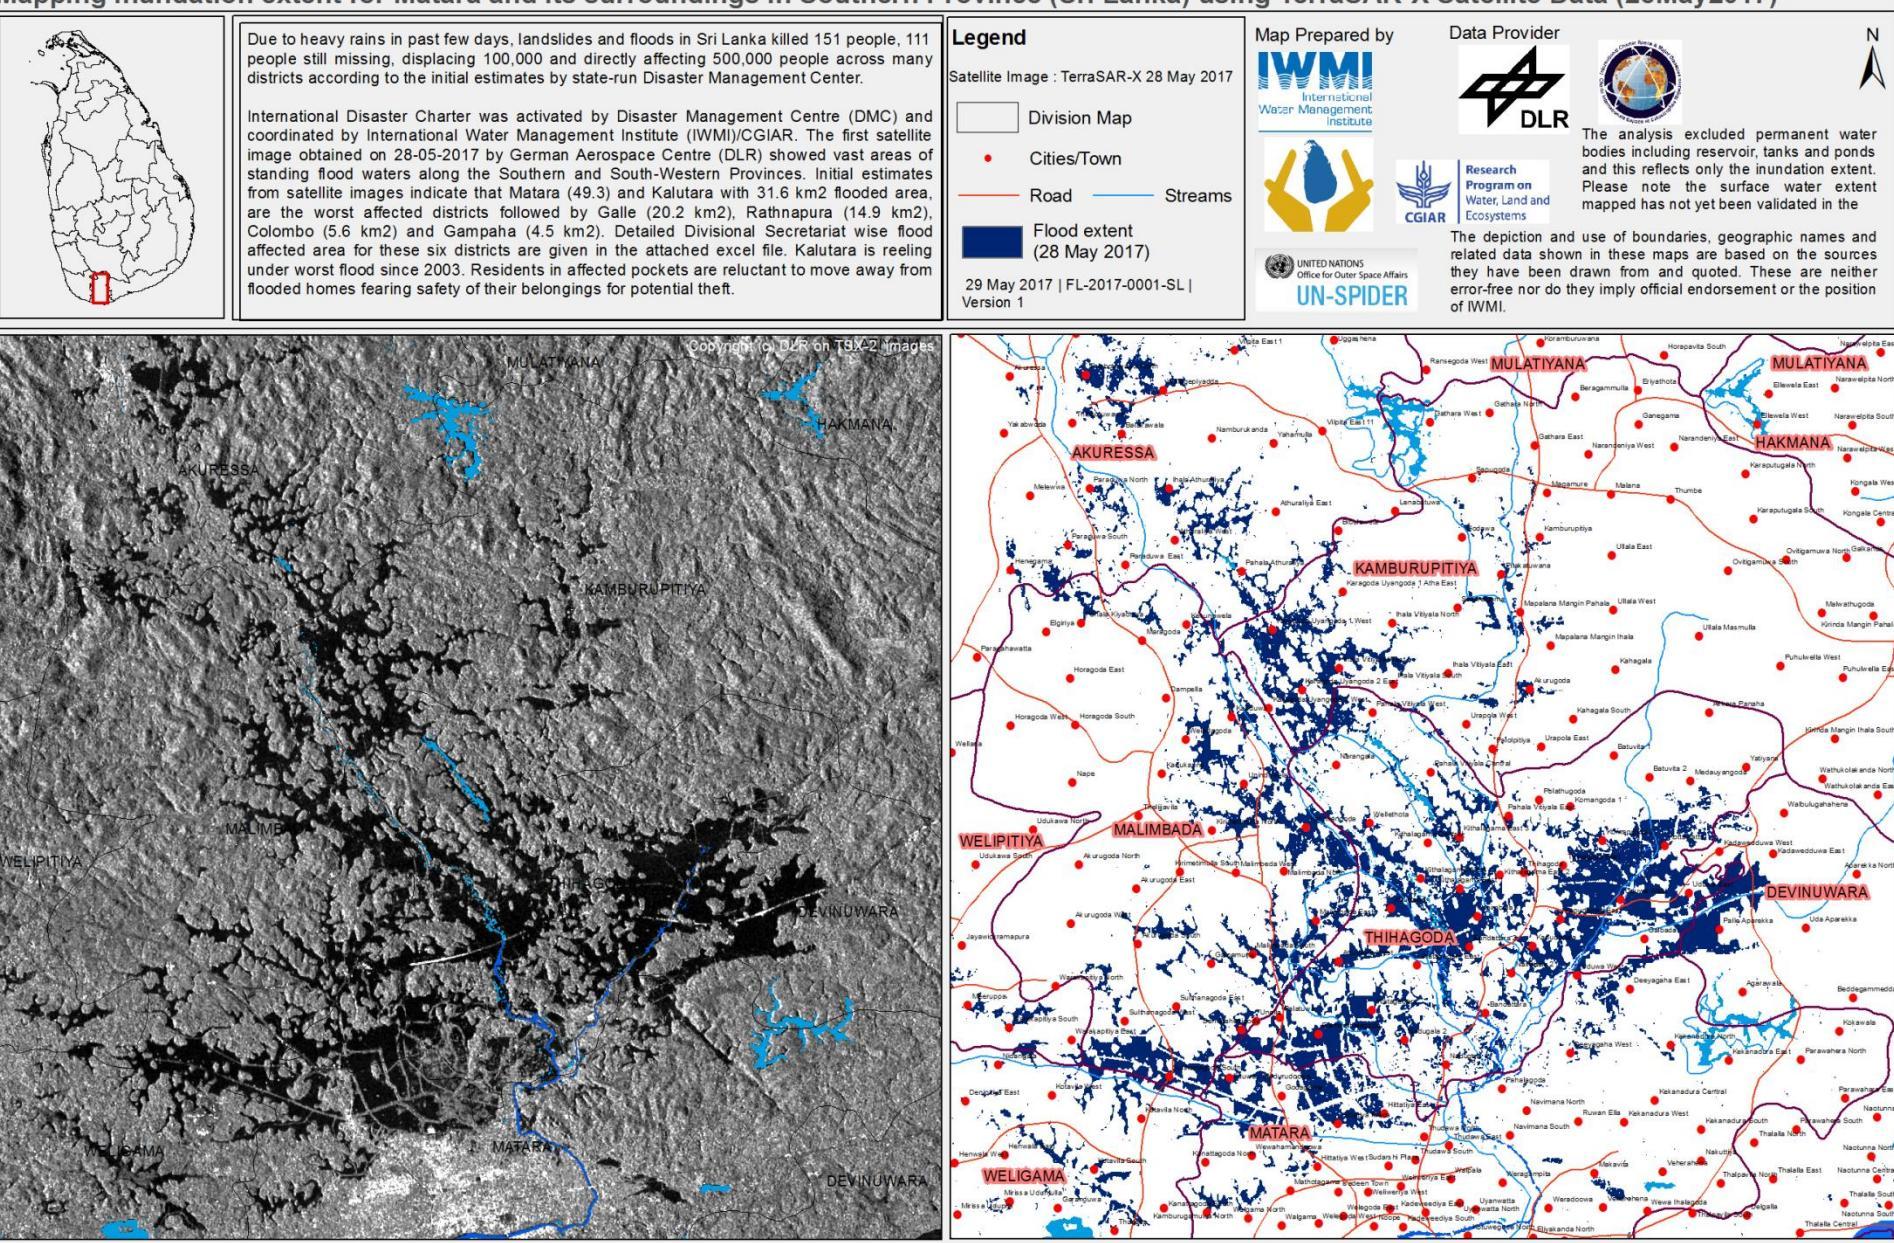
#### Mapping Inundation extent for Matara and its surroundings in Southern Province (Sri Lanka) using TerraSAR-X Satellite Data (28May2017)

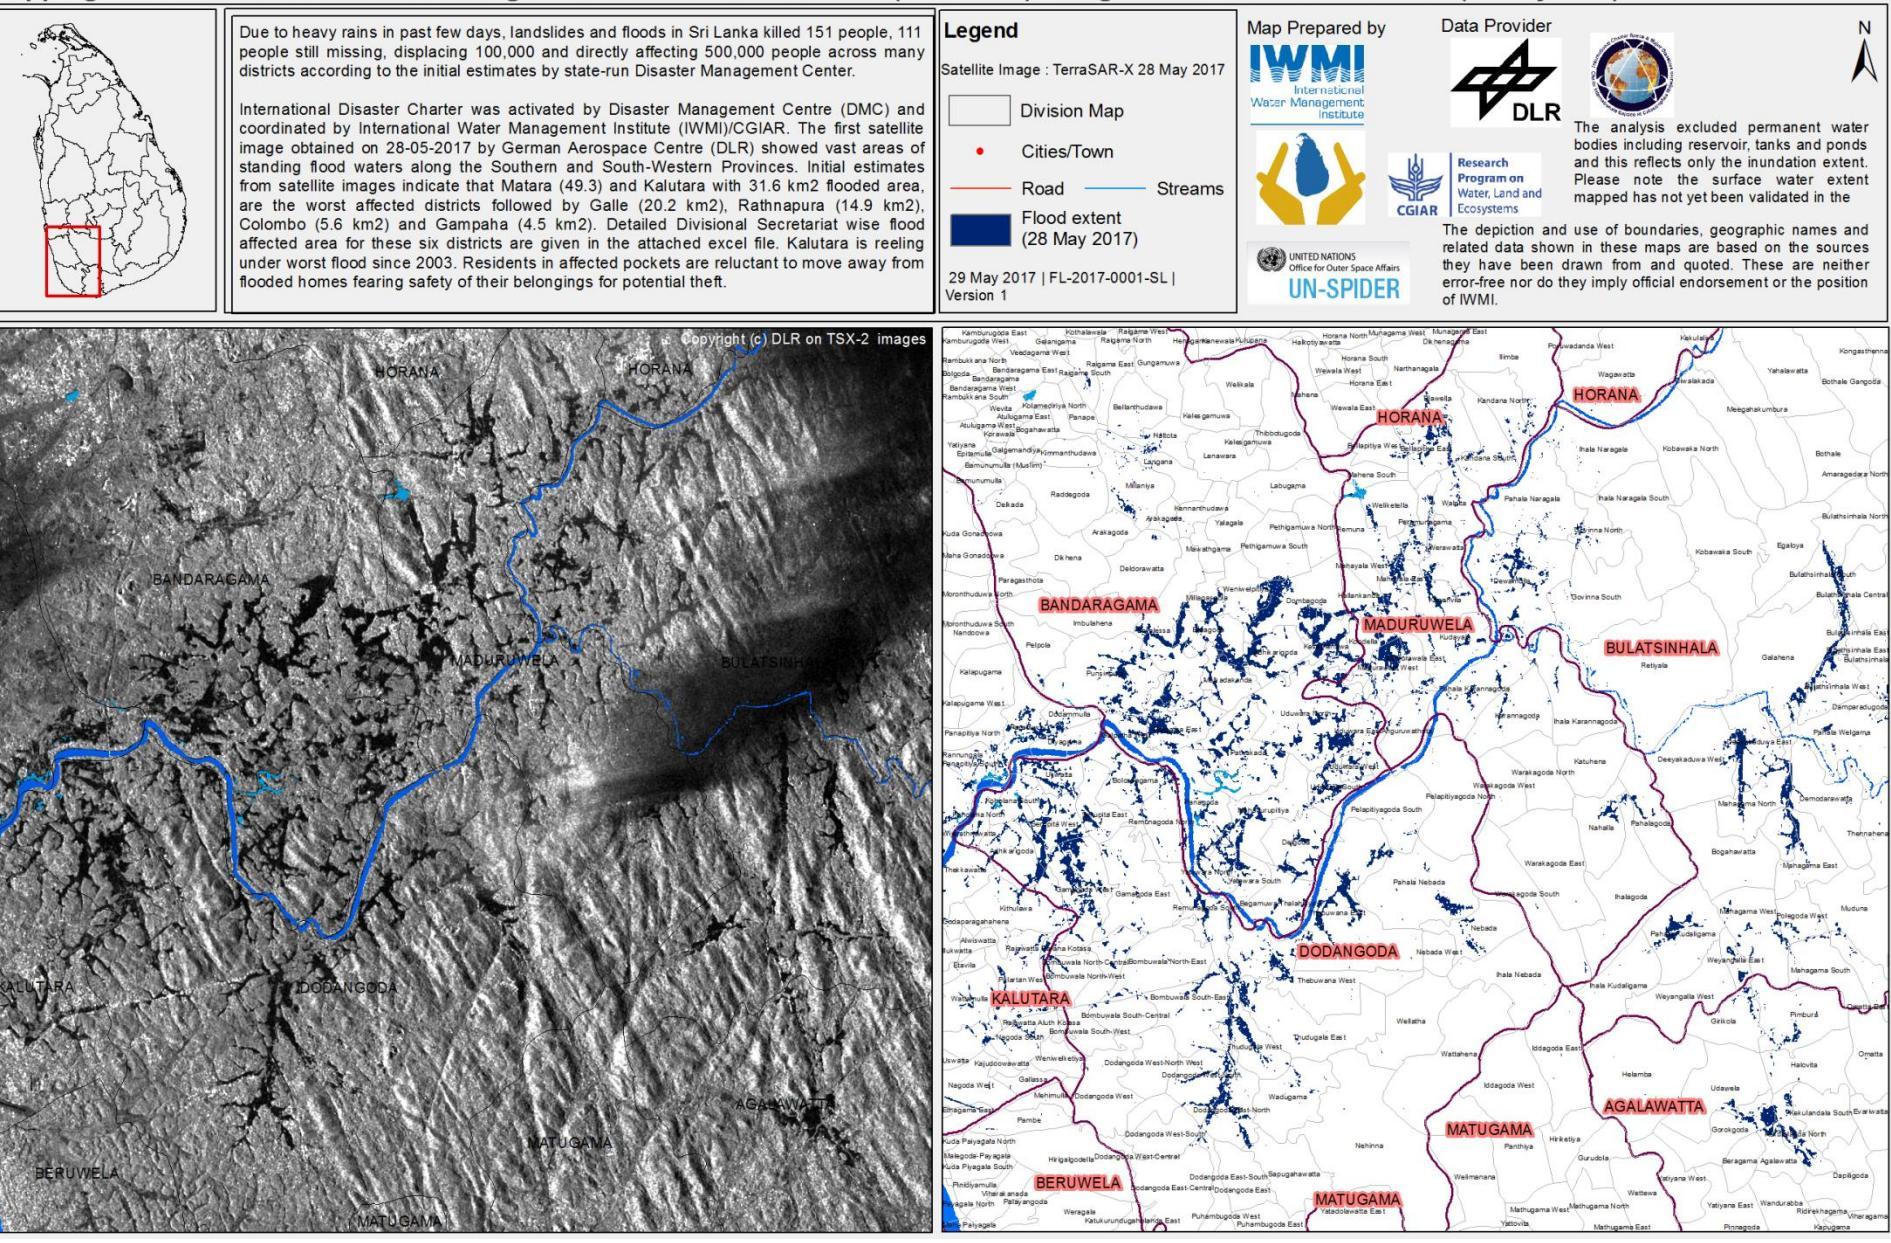
#### Mapping Inundation extent for Kalu Ganga basin in Western Province (Sri Lanka) using TerraSAR-X Satellite Data (28May2017)
